Engineering Design: Insights into Highway Bridge and Tunnel Disasters

INCOSE – Chesapeake Chapter
August 20, 2014
Laurel, MD

Earl F. Weener, Ph.D.
Member, NTSB

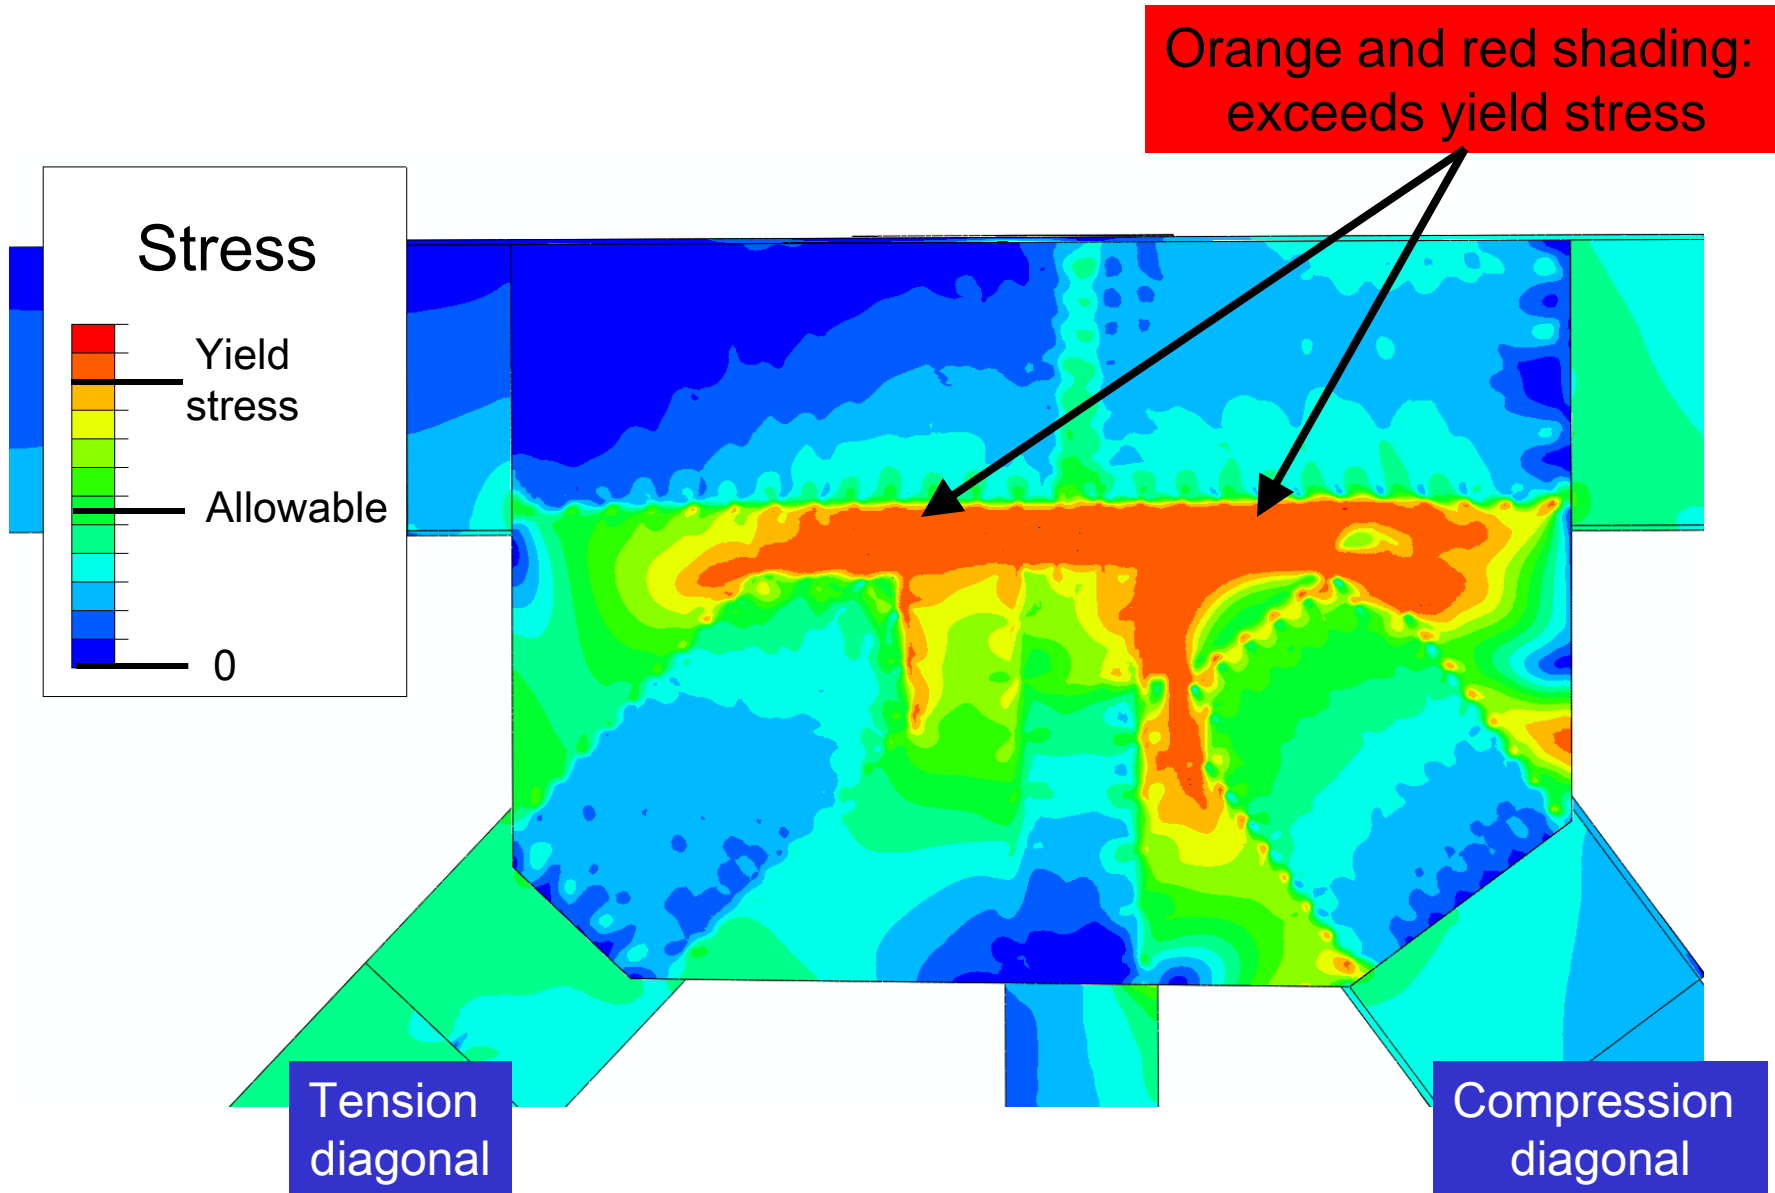
After 1977 and 1998 Modifications

- 1977 – modification to increase bridge deck thickness
 - Bridge dead load increase of 13.4%
- 1998 – modifications to the median barrier and outside railings
 - Bridge dead load increase of 6.1%

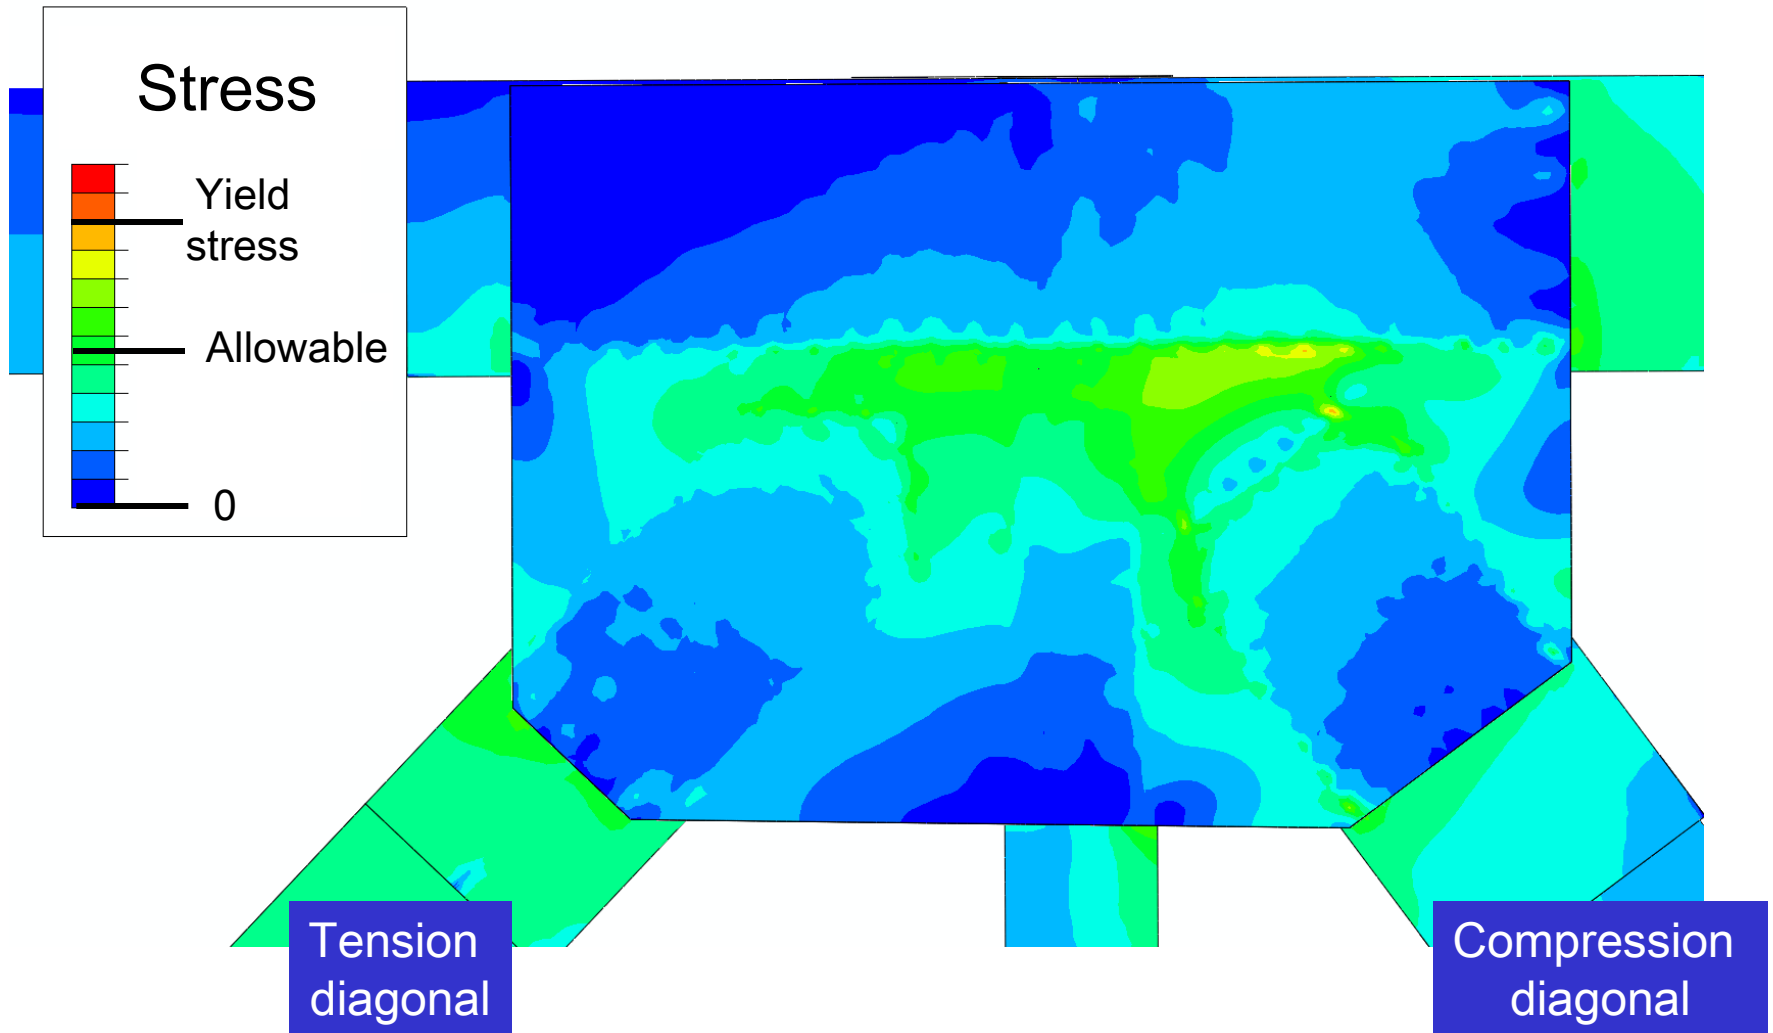
Accident Loads on 1-Inch-Thick Gusset Plates

The inadequate load capacity, due to design error of the gusset plates at the “U10” connection points by the engineering consulting firm responsible for the bridge design, which failed under a combination of:

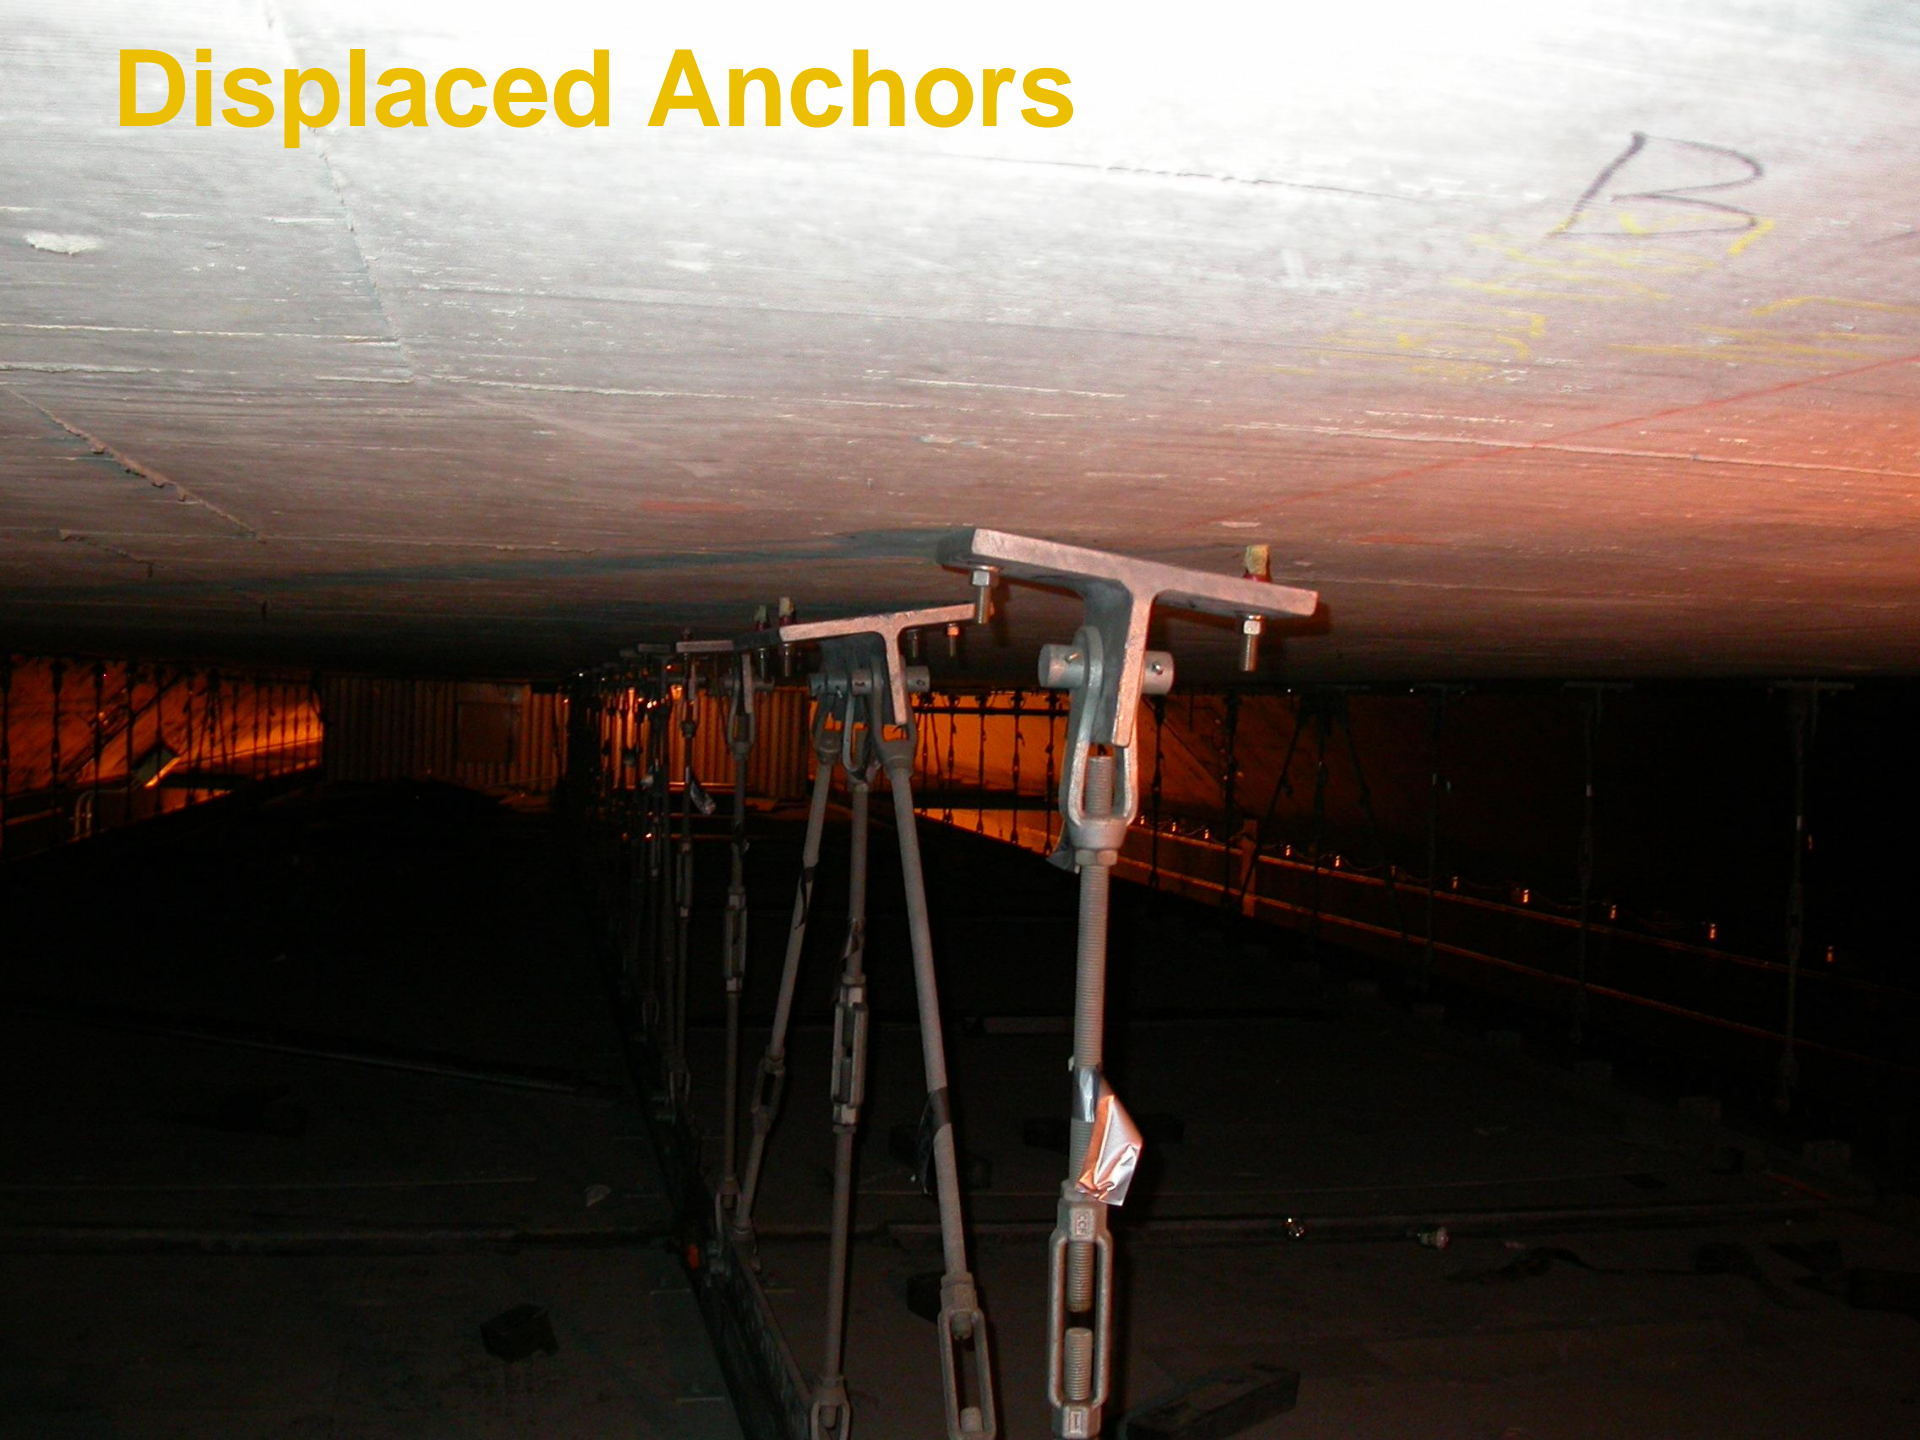
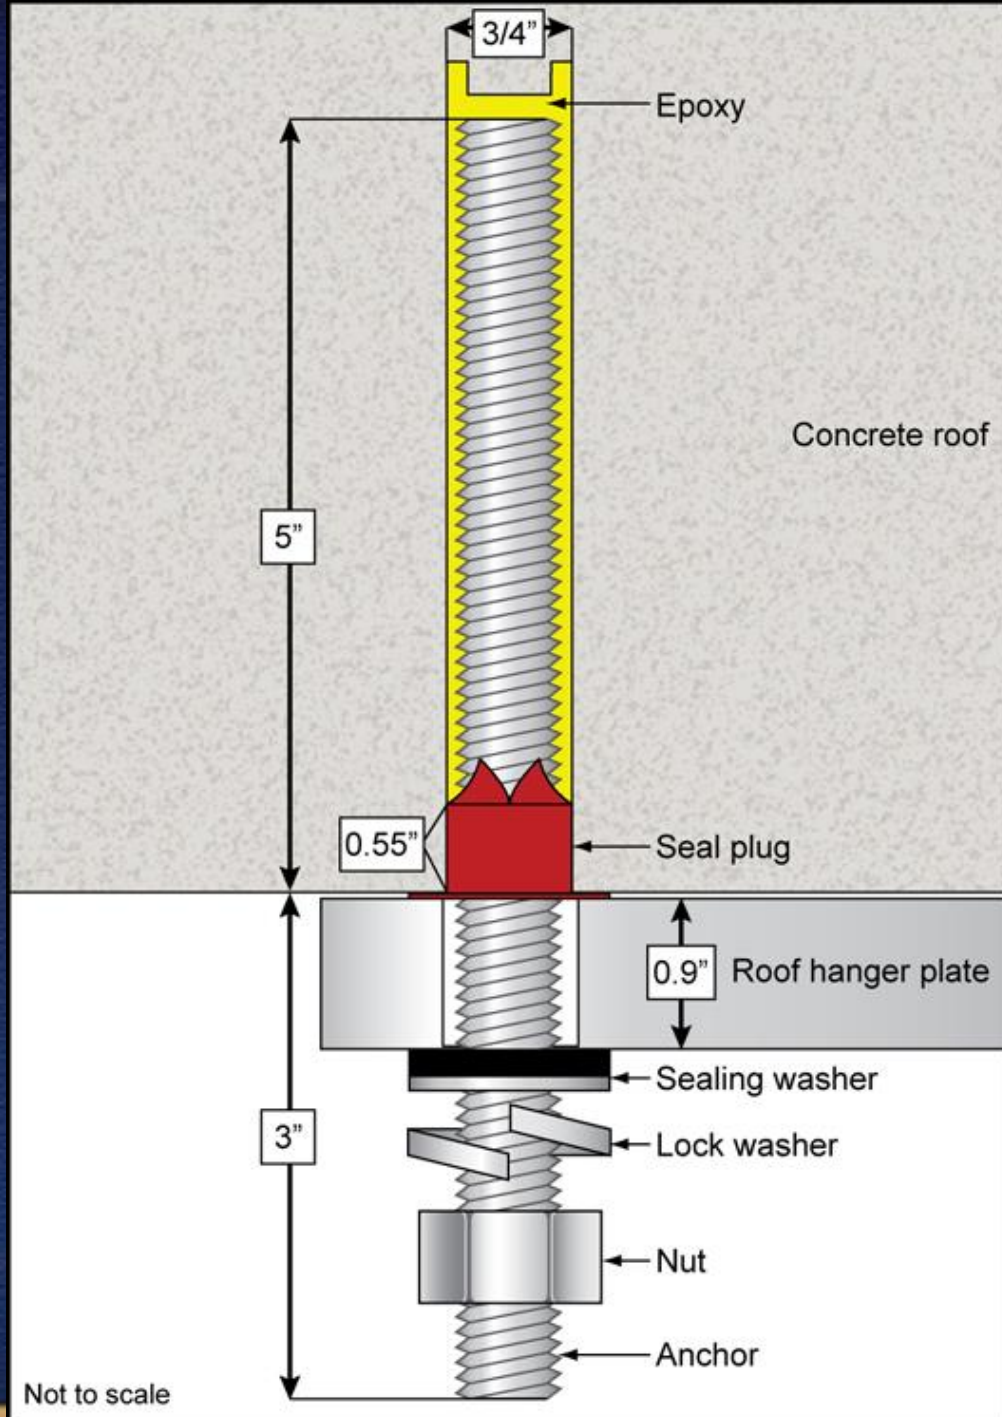
Displaced Anchors

The use of an epoxy anchor adhesive with poor creep that could not sustain long-term loads.

The failure of the project consultants to identify creep as a critical long-term issue, and account for it in the design, specifications, and approval process for an anchoring system.
